## Important Safety Recall Notice | April 11, 2024

Matrix Fitness has identified a safety risk associated with **Matrix T1xe, T3x, T3xm and T3xh-02 models sold between March 2018 – January 2024**. These products were sold with a “power cord keeper” bracket to prevent the power cord from becoming loose from the power socket posing a fire hazard. Matrix Fitness has that units in the field may not have had the power cord keeper bracket installed. While no injuries have been reported to date, **this condition is serious and could result in injury and/or property damage**. Matrix is therefore initiating a voluntary recall of these units to allow for inspection of the treadmills and, if needed, installation of the bracket.

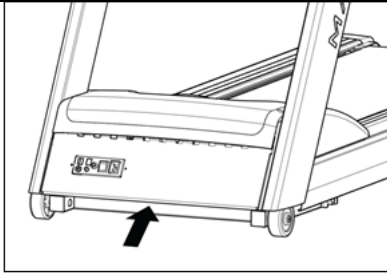
Serial number location

1. Must be an iteration of the T1x/T3x/T3xm/T3xh-02, per the chart below. Frame serial numbers are located on the front crossbar near the power switch. Below is an example of serial number FTM522180300528 and how to determine if the **year** and **month** are included with this recall.
2. If your T1x/T3x/T3xm/T3xh-02 has a production date of March 2018 (1803) and newer, Matrix asks that you inspect your unit to determine if it has an installed power cord keeper bracket. Please see photos for inspection protocol.

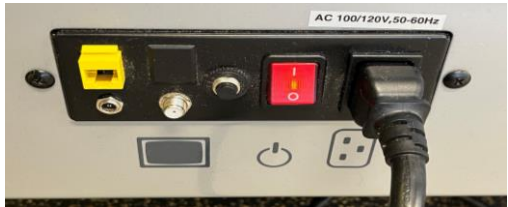
| Without Power Cord Keeper Bracket (Request Bracket) | With Power Cord Keeper Bracket (Report to Matrix) |

5. **Schedule rework or order parts:**
  - a. This is a simple upgrade that requires only a screwdriver to install and can easily be performed by facility personnel once they have ordered the bracket. However, if preferred, JHTNA will dispatch service technicians to either inspect the unit and/or complete the work, without charge. The power-cord bracket will secure the power cord to the socket. **To Order Parts or schedule installation**, contact our customer technical support team by scanning the QR code above or emailing [reworks@johnsonfit.com](mailto:reworks@johnsonfit.com).
